ROYAL AIRCRAFT ESTABLISHMENT

Technical Report 85059

**A COMPARISON OF THE FATIGUE
PERFORMANCE OF WOVEN AND
NON-WOVEN CFRP LAMINATES**

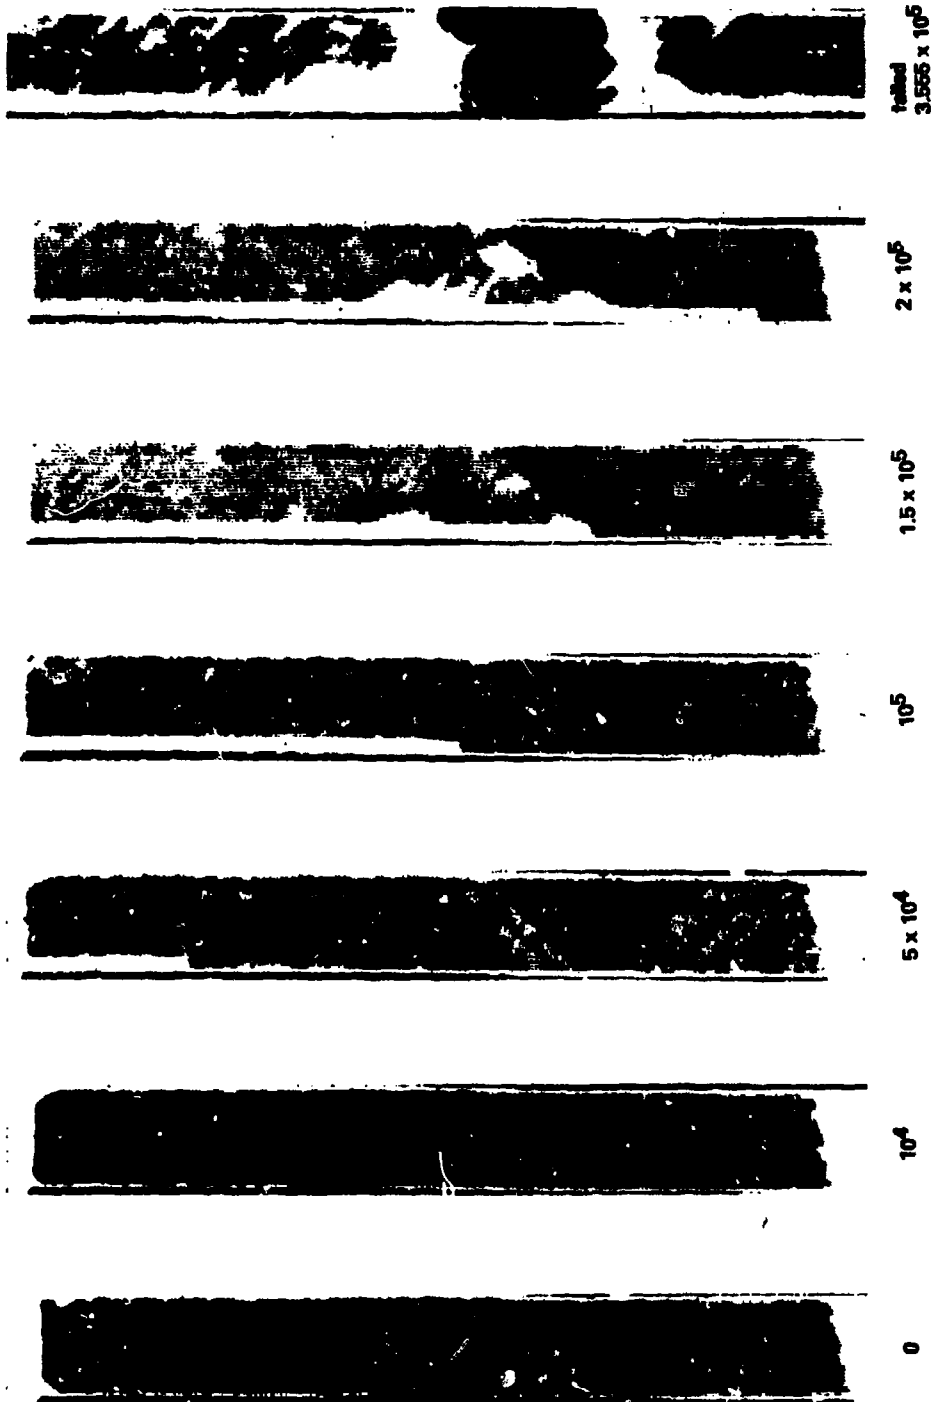
Fig 58 Ultrasonic C-scans of a non-woven plain coupon with layup E ($\pm 45, 02$) tested in reversed axial fatigue at the stress level giving a mean life of 100000 cycles. Left to right, scans after: 0 cycles at 1 dB steps, 10000 cycles at 1 dB steps, 50000 cycles at 1 dB steps, 100000 cycles at 1 dB steps, 150000 cycles at 1 dB steps, 200000 cycles at 1 dB steps, 355500 cycles at 1 dB steps — failure

Ultrasonic C-scanning of plain non-woven coupons revealed edge damage which initiated from one end and grew along one edge (Fig 58). Eventually light areas were initiated within the coupon width away from the edges through which the coupon failed. Holed non-woven coupons revealed damage around the holes after 10000 cycles (Fig 59) which grew longitudinally to several hole diameters distance after 1 million cycles. Eventually the damage reached the coupon ends and had also grown across the coupon width.

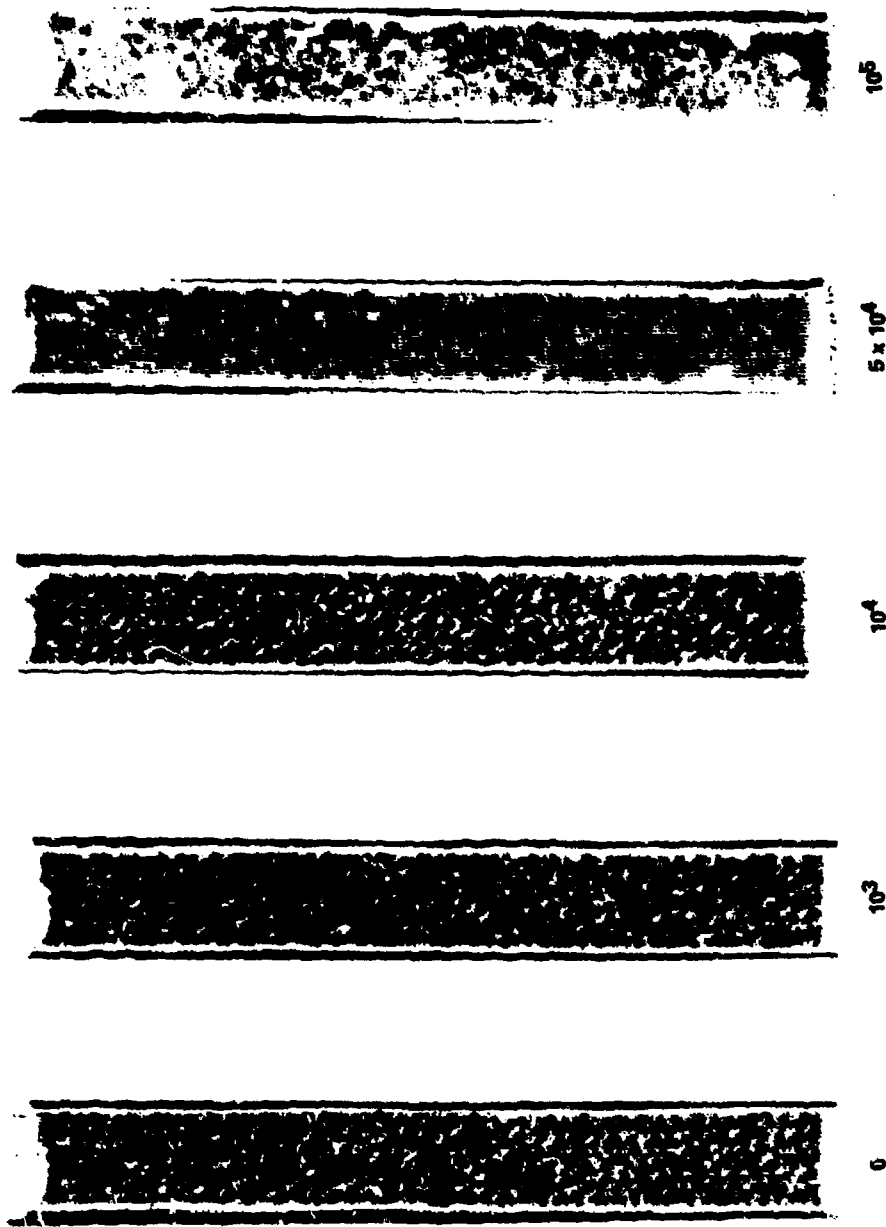
Fig 60 Ultrasonic C-scans of a woven plain coupon with layup E (-45,02) tested in reversed axial fatigue at the stress level giving a mean life of 100,000 cycles. Left to right, scans after: 0 cycles at 1 dB steps, 1000 cycles at 1 dB steps, 10000 cycles at 1 dB steps, 50000 cycles at 1 dB steps, 100000 cycles at 1 dB steps

Ultrasonic C-scanning of plain woven coupons revealed the gradual lightening with increasing numbers of fatigue load cycles observed in the other woven laminates (Fig 60). Some edge induced damage was apparent after 50000 cycles. The holed woven coupons exhibited a similar effect to that observed in the non-woven coupons in which damage was observed around the hole after only 1000 cycles and grew longitudinally to extend along half the coupon length after 10000 cycles. The damage then grew transversely from the hole across the width.
